Road Safety Assessment

US Route 1 (Tower Hill Road) | South Kingstown, RI

OCTOBER 2017

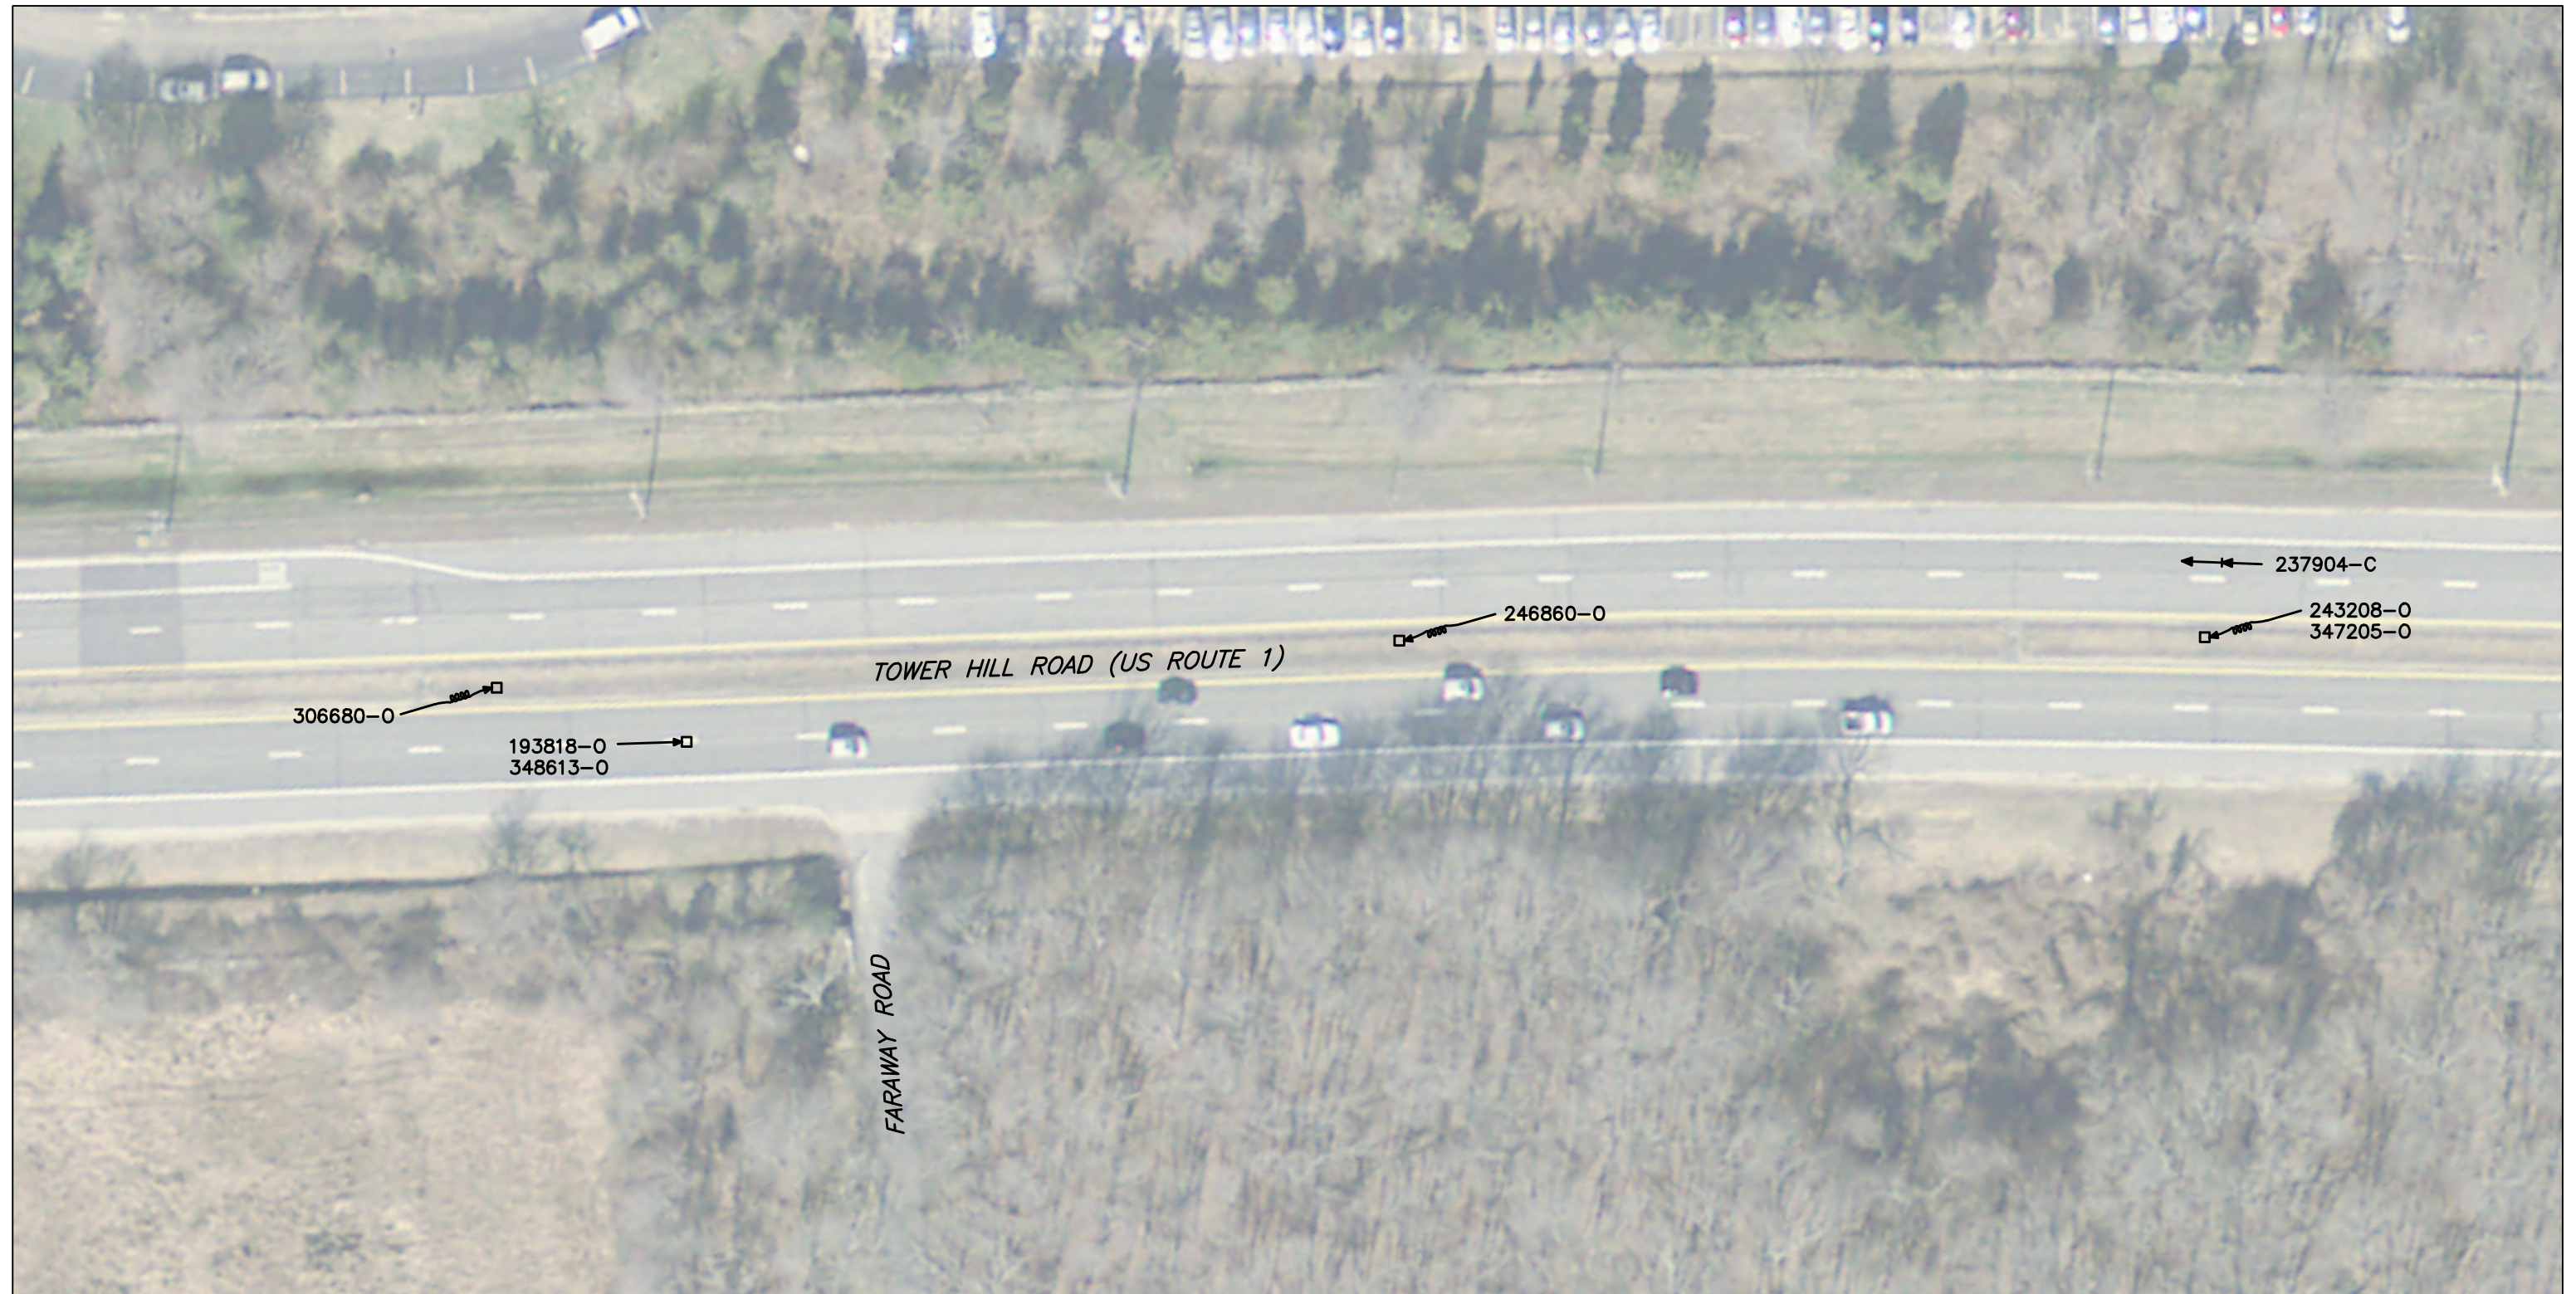
Figure 2-1a

Along US Route 1, between South County Commons and Saugatucket Road, 53 total crashes along the corridor that occurred between 2011 and 2015. Of those 53 crashes, 24 are roadway departure crashes occurred along the segment. One of the total crashes (2%) was K-type, one of the crashes (12%) was B-type injury crash, 12 of those crashes (23%) were C-type injury crashes while the remaining 74 percent were property damage only crashes. It should also be noted that the one fatal crash (K-type injury) was roadway departure related.

Collision Diagram

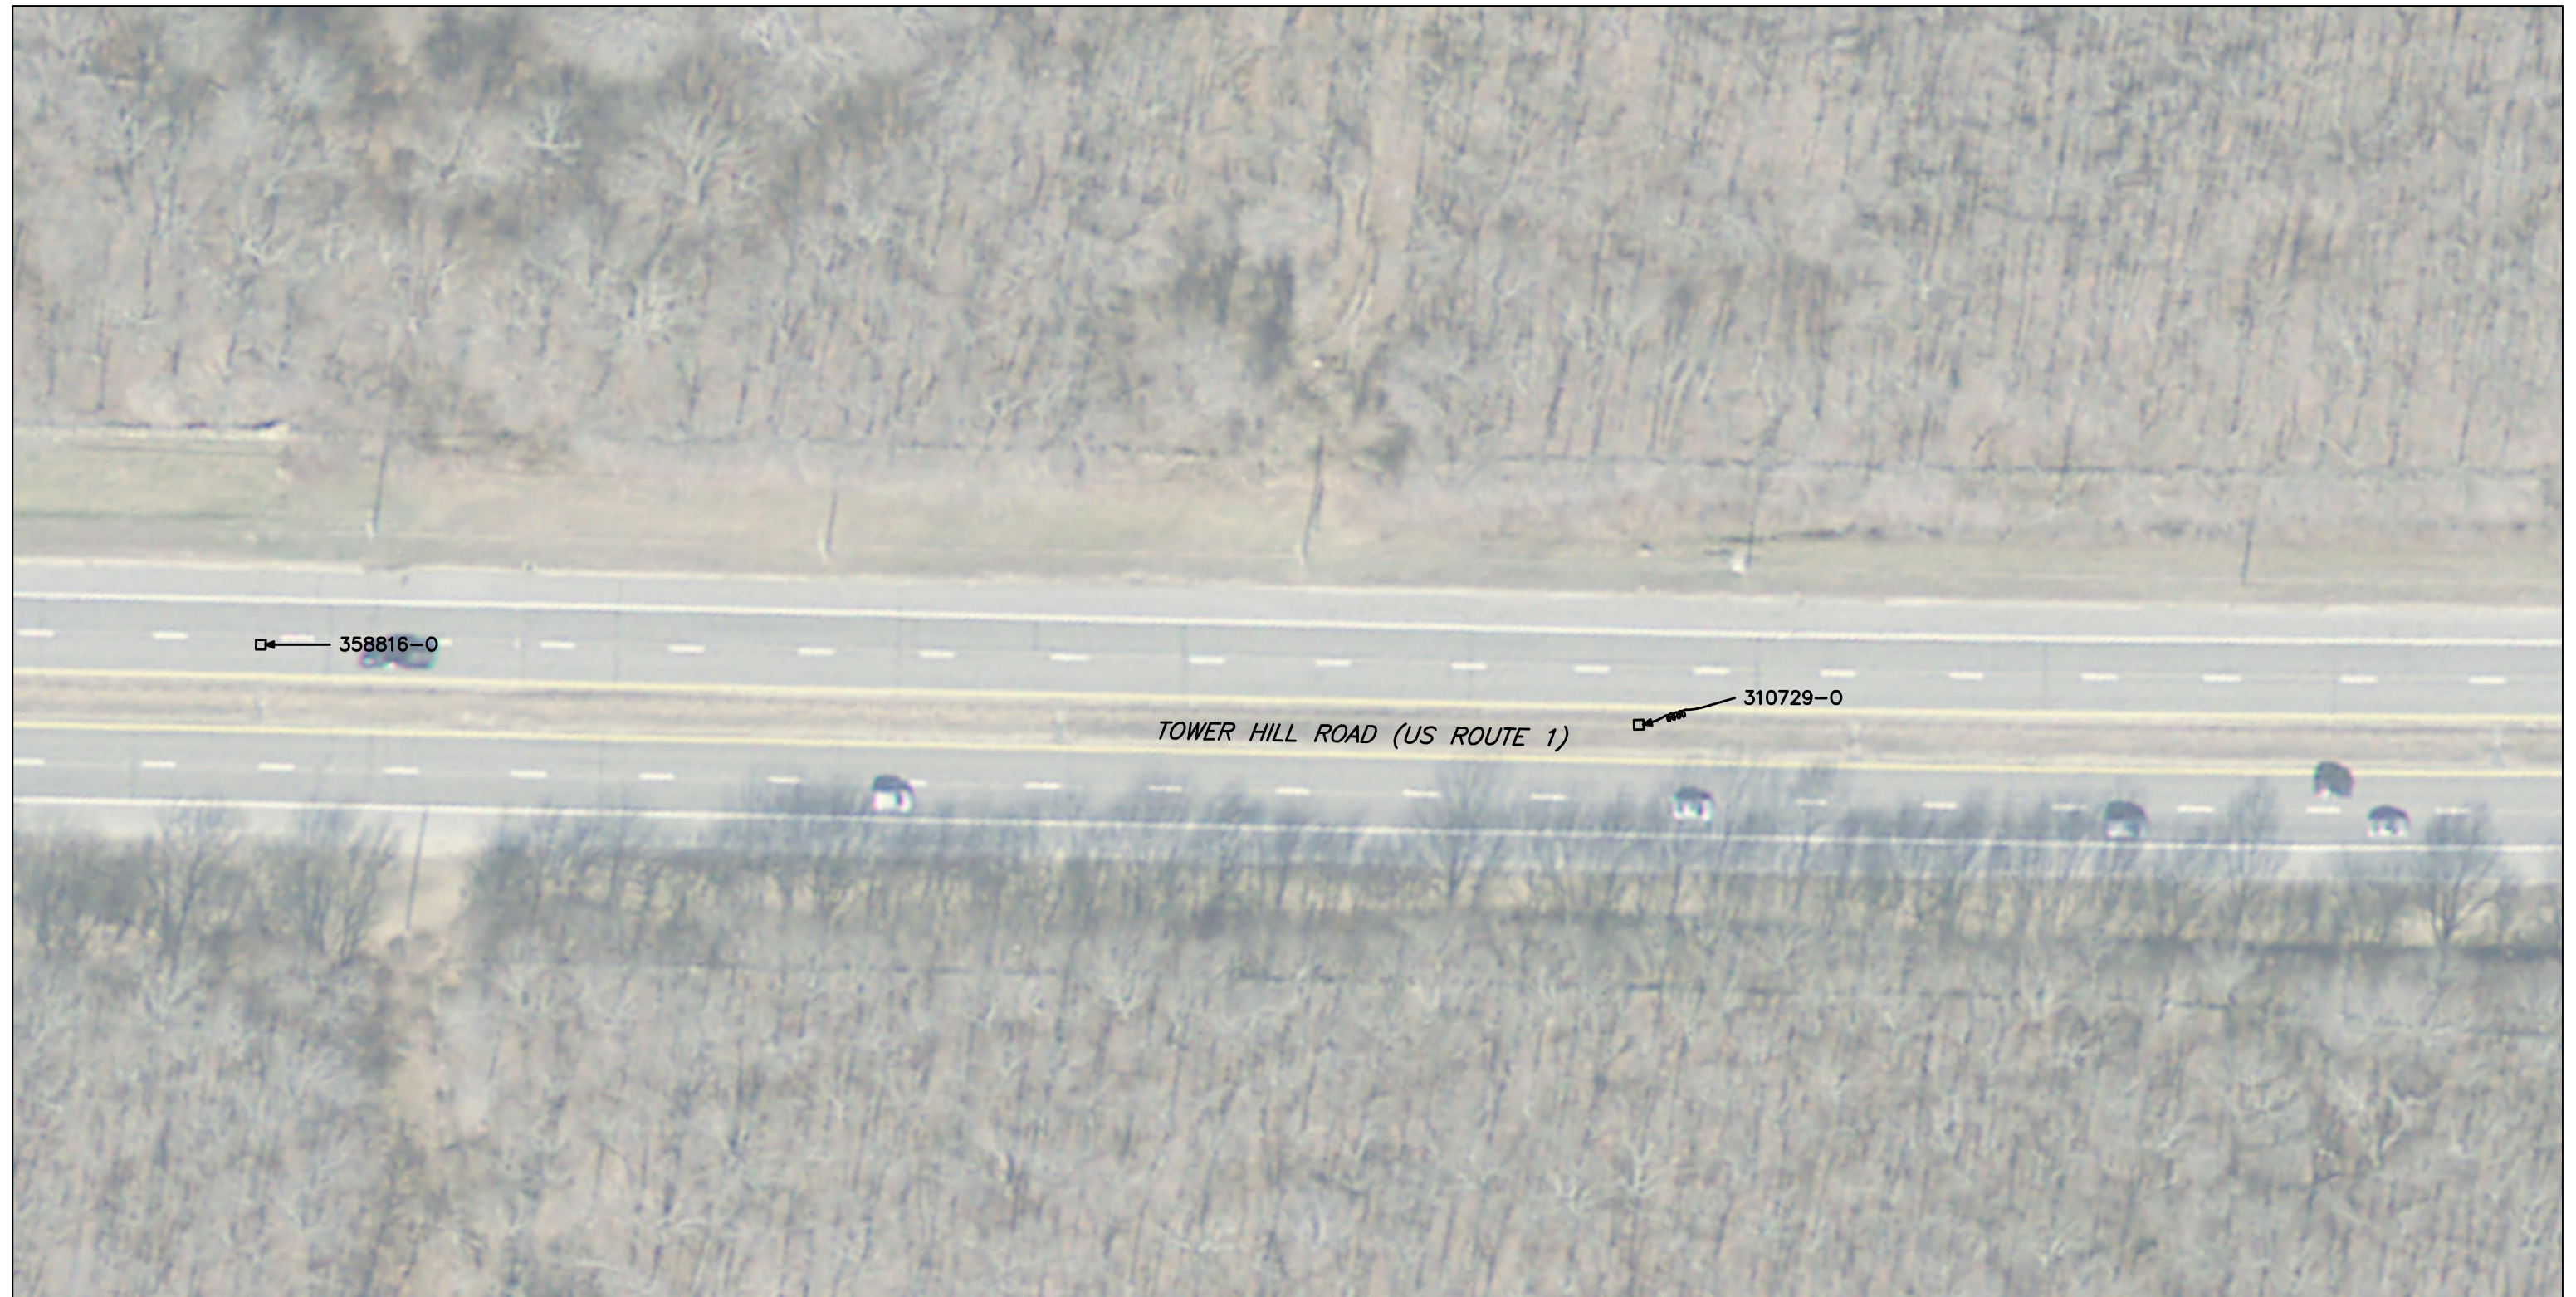
Figure 2-1b

Collision Diagram

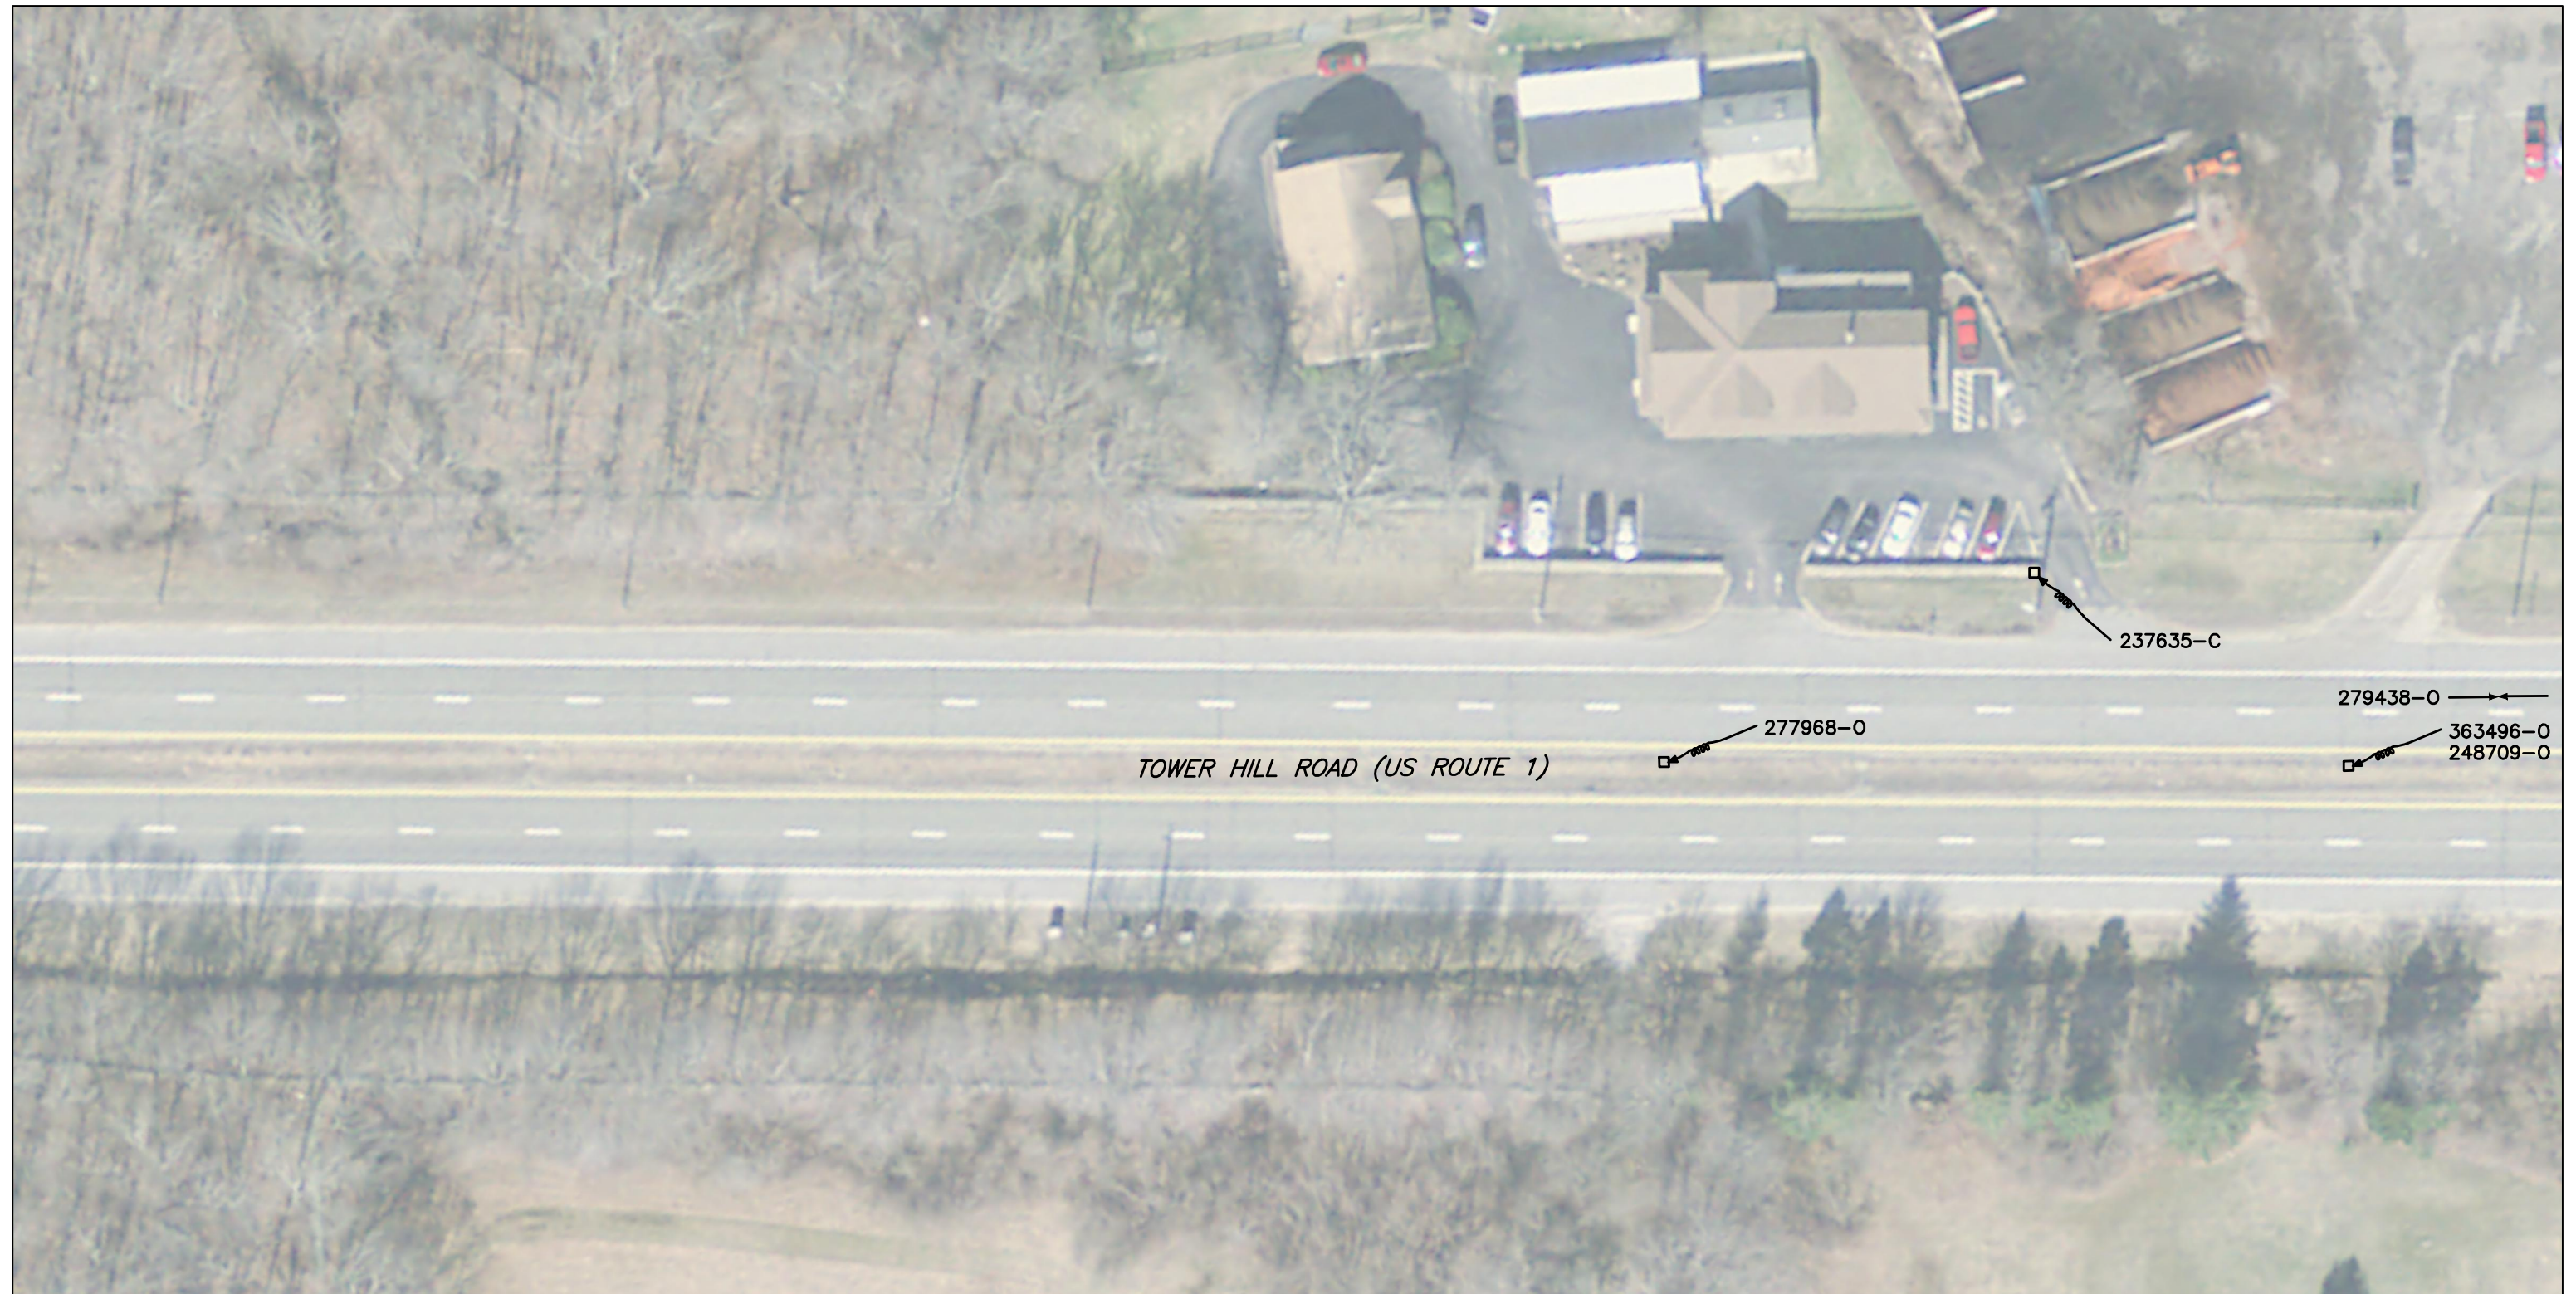
Figure 2-1c

Collision Diagram

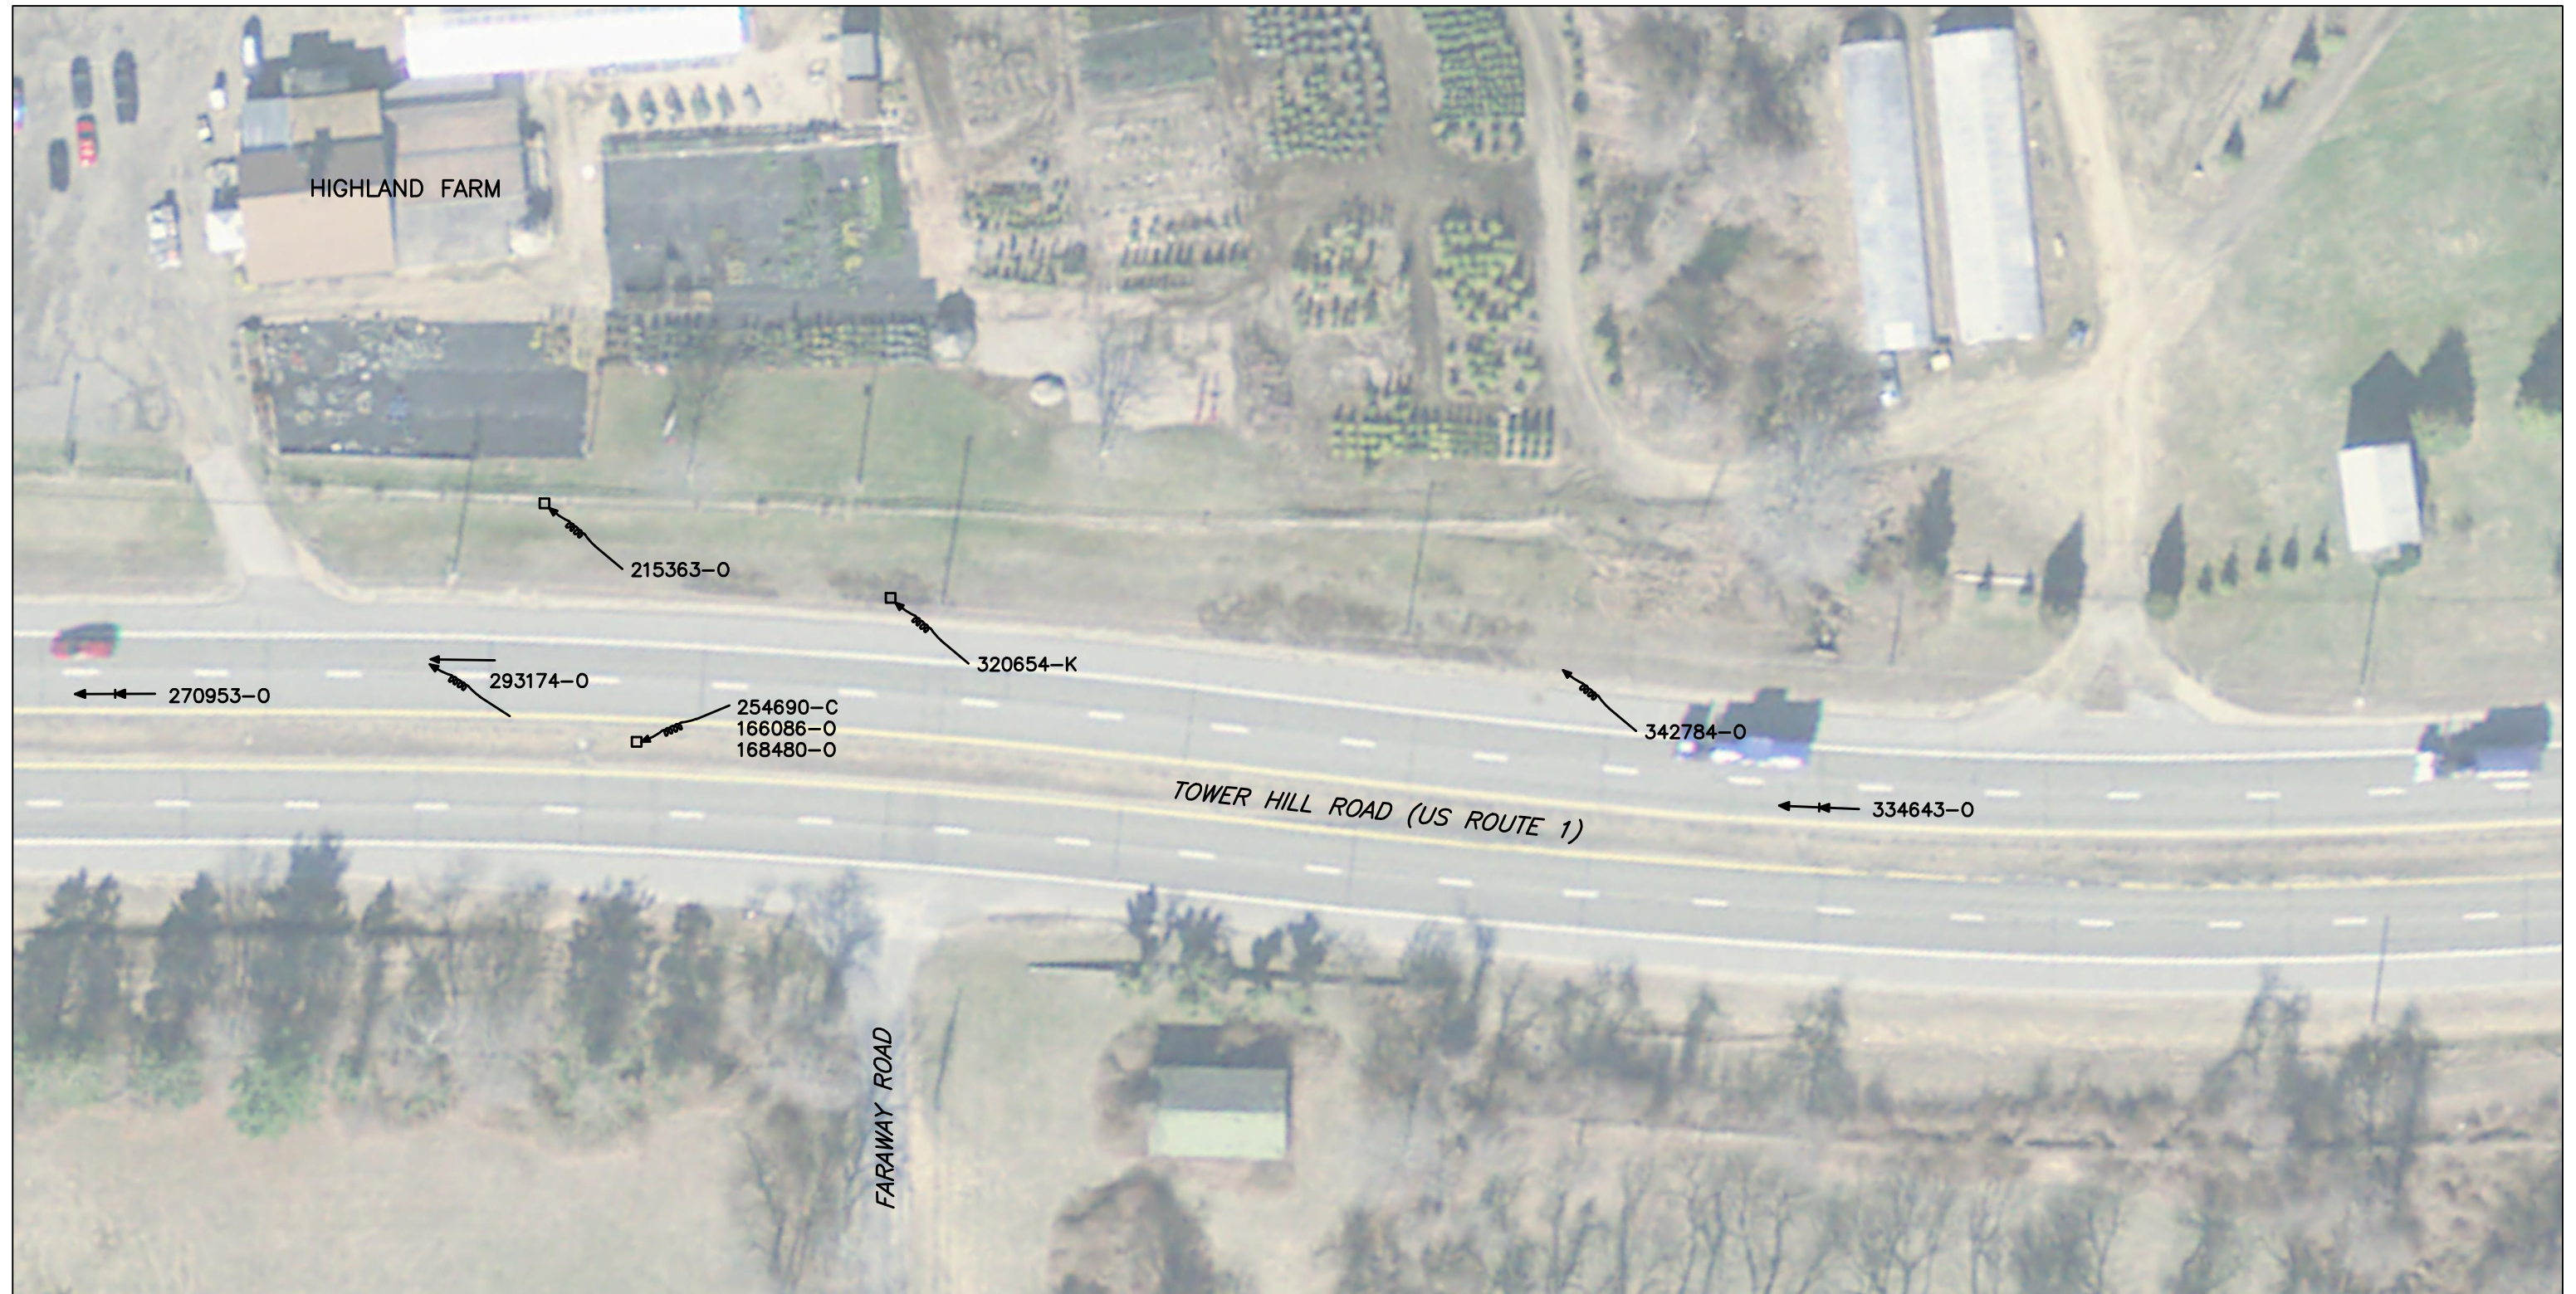
Figure 2-1d

Collision Diagram

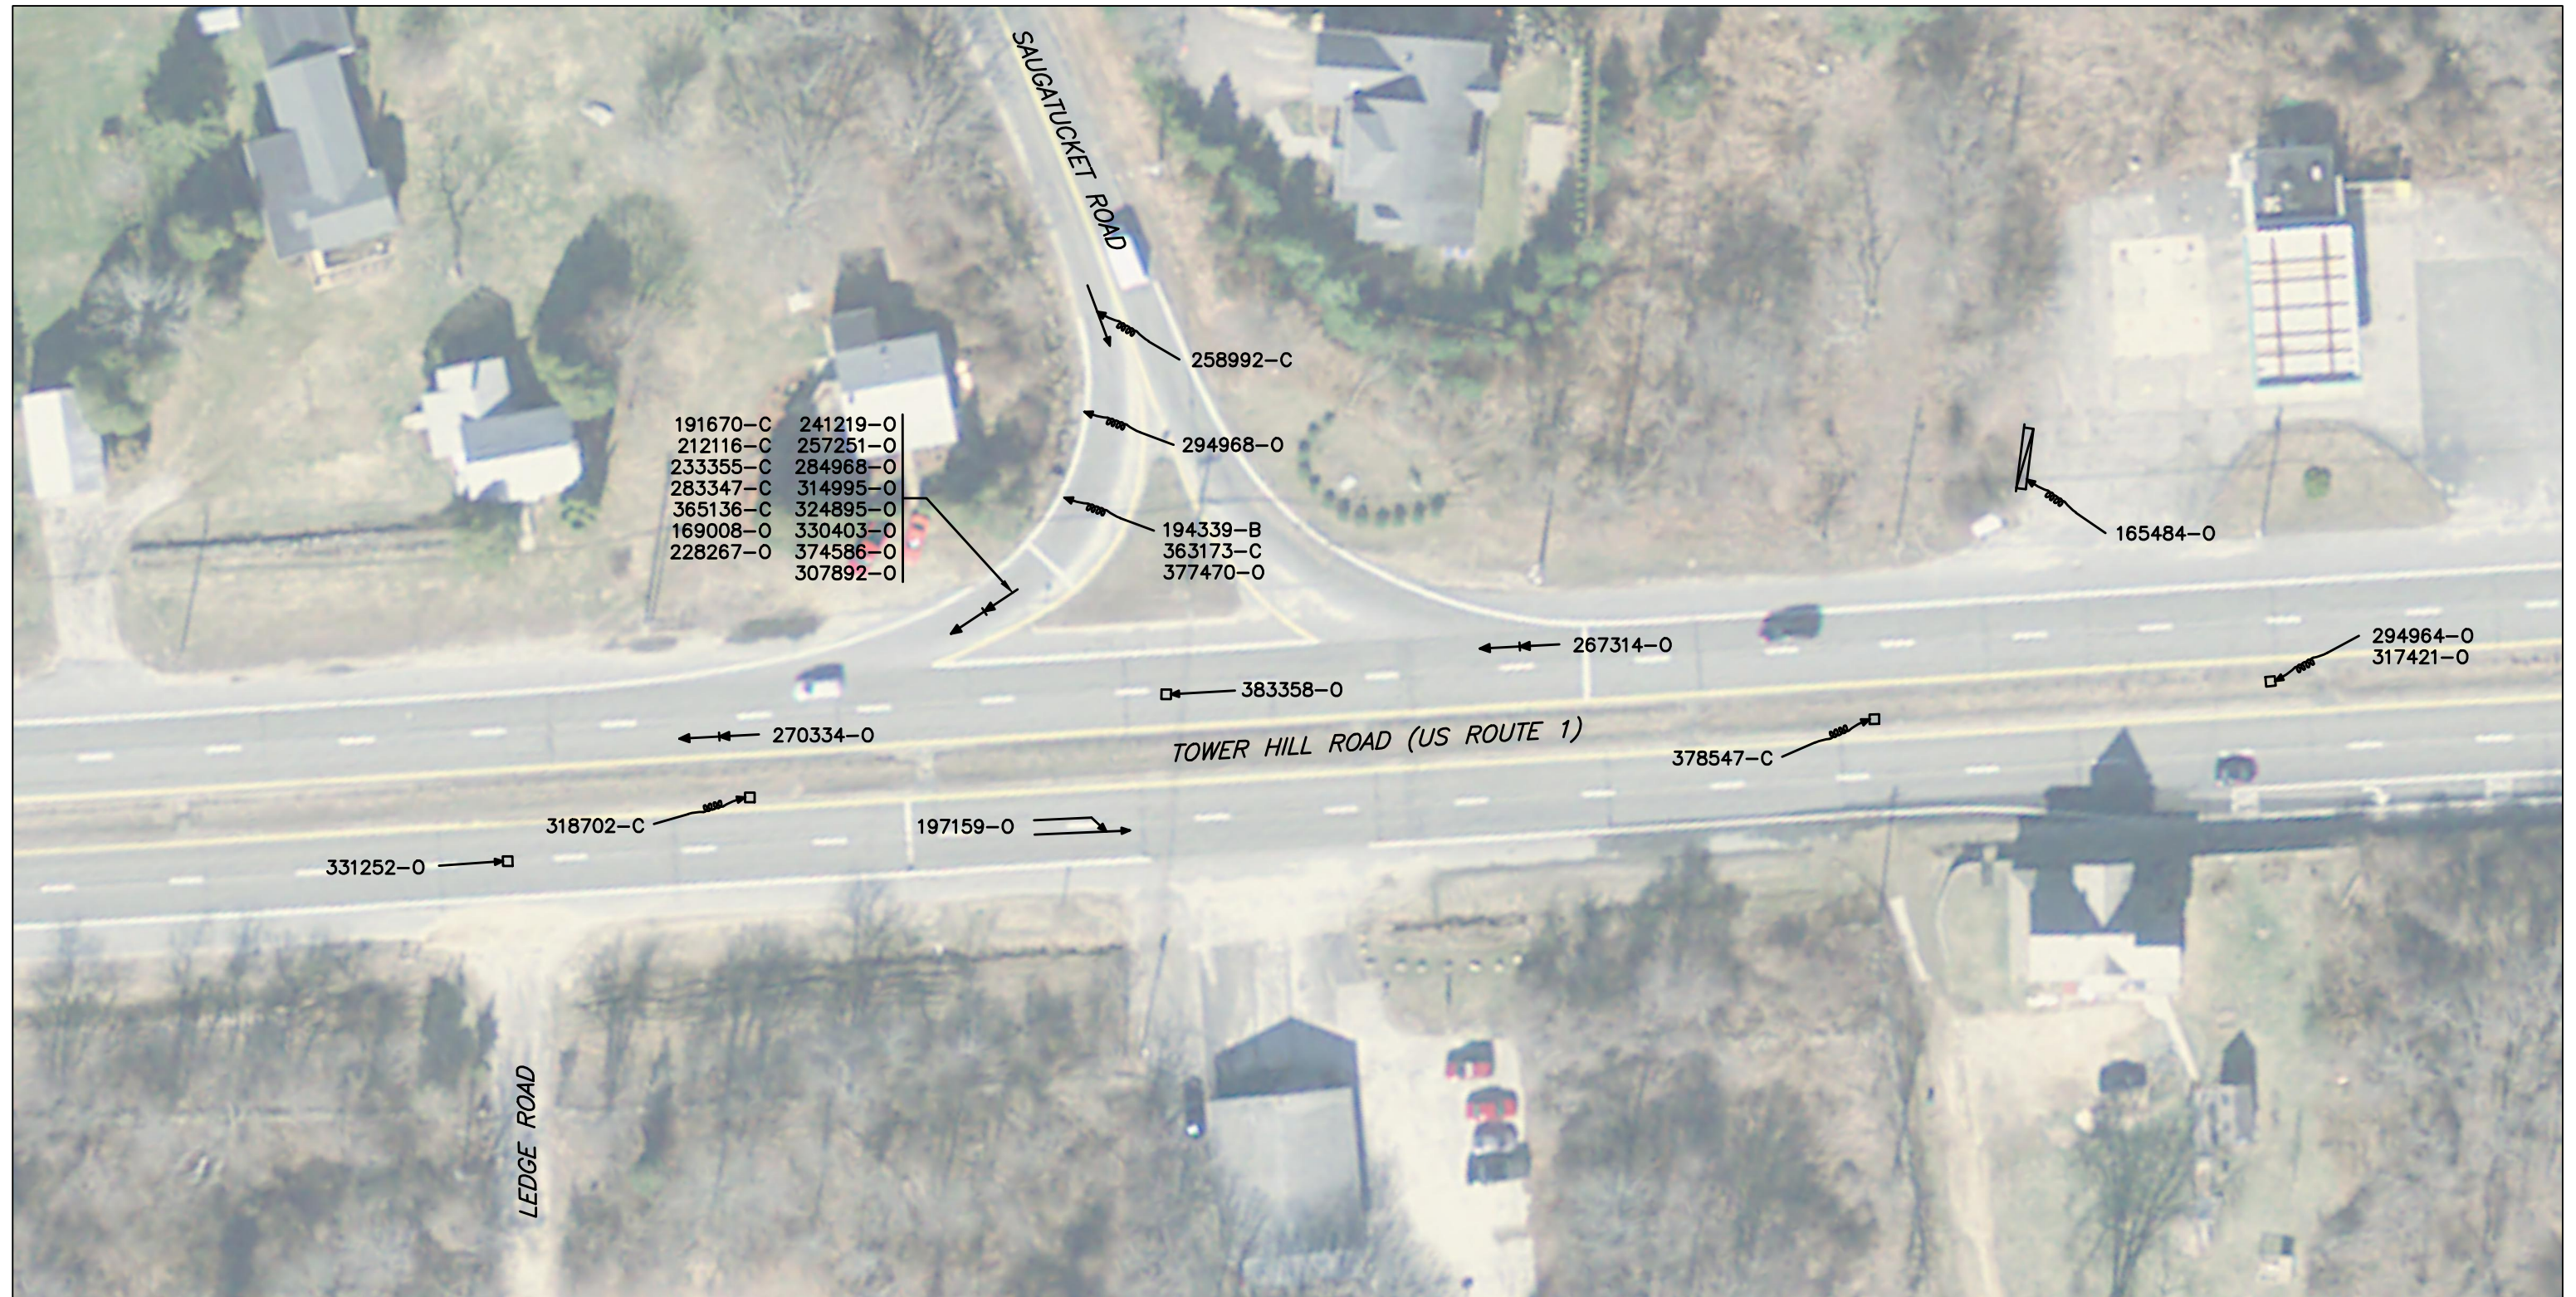
Figure 2-1e

Collision Diagram

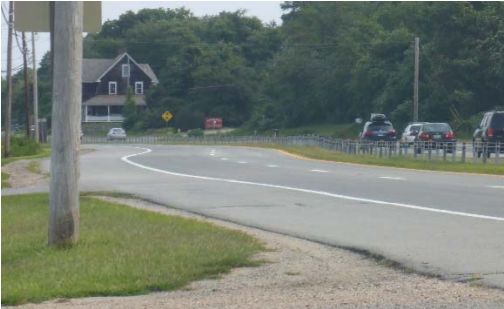
OBSERVATION	IMMEDIATE TERM IMPROVEMENTS Under 6 months	NEAR TERM IMPROVEMENTS Under 2 years	LONGER TERM IMPROVEMENTS Over 2 years	COMMENTS
<p>History of Roadway Departure Crashes – A number of roadway departure crashes occurred along the corridor within the last five years.</p>

<p>ENGINEERING:</p> <p>1.1 Install post mounted delineators in both directions on the left and right-side of the roadway to better delineate the edge of pavement.</p> <p>1.2 Restripe US Route 1 to provide a larger left side shoulder and smooth striping of the curve.</p>	<p>ENGINEERING:</p> <p>1.3 Consider the installation of High Friction Surface Treatment (HFST) on US Route 1 within the curve.</p> <p>1.4 Replace missing recessed pavement markers (RPM) throughout the corridor.</p>	<p>ENGINEERING:</p> <p>1.5 Consider the installation of rumble strip/stripes.</p>	<p>Longer-term improvements are intended to address persistent safety issues if observed in the future.</p> <p>Rumble strip/stripes shall only be considered at locations with no residential areas adjacent to the roadway.</p>

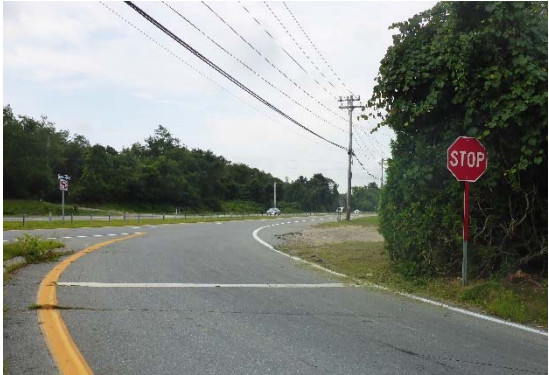
<p>Inadequate Vehicle Sight Lines – Inadequate vehicle sight lines, at the intersection of US Route 1 at Saugatucket Road, presents a potential hazard. This is caused by overgrown vegetation, the horizontal and vertical curves of the channelized right-turn onto US Route 1 from Saugatucket Road.</p>

<p>ENGINEERING:</p> <p>1.6 Trim overgrown vegetation along US Route 1 at the intersection with Saugatucket Road.</p>			
<p>Missing and Inconsistent Guardrail – Guardrail along the corridor was observed to be non-complaint or inconsistently placed leaving hazards (trees, ledge, slopes, etc.) within the clear zone unprotected.</p>	<p>ENGINEERING:</p> <p>1.7 Evaluate the existing guardrail along the corridor to determine if the current installation is appropriate. Revise guardrail accordingly.</p> <p>1.8 Review clear zones along the corridor. If a roadside hazard is within the clear zone remove the hazard if feasible. If not, protect the hazard accordingly.</p>	<p>ENGINEERING:</p> <p>1.9 Consider replacing a section of cable guardrail within the curve on US Route 1 per RIDOT guidance to install semi-rigid (w-beam, thrie beam) guardrail within curves.</p>

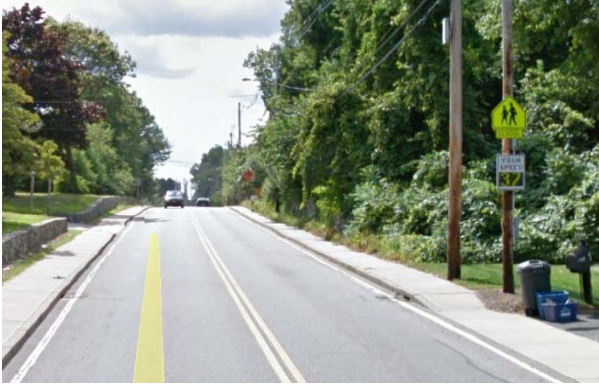
OBSERVATION	IMMEDIATE TERM IMPROVEMENTS Under 6 months	NEAR TERM IMPROVEMENTS Under 2 years	LONGER TERM IMPROVEMENTS Over 2 years	COMMENTS
<p>Lack of signage– Guide/regulatory/warning signs are small, inconsistent, unclear, obstructed, or missing along US Route 1 (Tower Hill Road).</p>	<p>ENGINEERING:</p> <p>1.11 Consider a comprehensive sign audit to verify sign height, retro-reflectivity, current sign standards, consistency, redundancy, and unnecessary signs. Revise signs accordingly.</p> <p>1.12 Install reflective sign strips on all sign posts.</p>			
<p>Speeding – Vehicle appear to be traveling at a high rate of speed on US Route 1 (Tower Hill Road).</p>

<p>Wakefield Street, West Warwick</p>	<p>ENFORCEMENT:</p> <p>1.13 Consider a speeding enforcement campaign on US Route 1 to discourage speeding.</p> <p>ENGINEERING:</p> <p>1.14 Remove all speed limit signs along the corridor and install new signs space more appropriately.</p>	<p>ENGINEERING:</p> <p>1.15 Install dynamic speed feedback signs to discourage speeding along the corridor.</p>		<p>Since the completion of the Roadway Safety Assessment, a speed study was completed, as described in Chapter 3.</p>

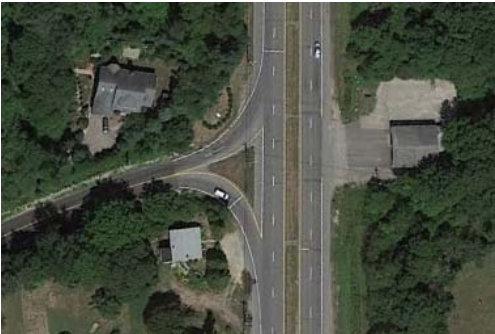
<p>Lack of sufficient street lighting – No street lighting provided along the corridor which may contribute to the number of crashes at this location.</p>	<p>ENGINEERING:</p> <p>1.16 Conduct lighting study to determine deficiencies and potential improvements.</p>	<p>ENGINEERING:</p> <p>1.17 Implement area-wide lighting installation to improve safety for vehicles and other road users.</p>		<p>Coordinate with National Grid for lighting improvements.</p>
<p>Complex Intersection Geometry – Wide intersection geometry with a channelized median at the intersection of US Route 1 at Saugatucket Road in combination with the horizontal curve and high travel speeds along US Route 1 result in driver confusion and rear-end and roadway departure crashes at this location.</p>

<p>ENGINEERING:</p> <p>1.18 Install stop ahead signs on Saugatucket Road.</p> <p>1.19 Install intersection warning signs on US Route 1 to warn vehicles of the approaching unsignalized intersection.</p>	<p>ENGINEERING:</p> <p>1.20 Consider the installation of High Friction Surface Treatment (HFST) on the entrance to Saugatucket Road from US Route 1.</p>	<p>ENGINEERING:</p> <p>1.21 Install acceleration and deceleration lanes at the intersection of US Route 1 and Saugatucket Road.</p> <p>1.22 Consider geometric reconstruction to “T” up intersection of US Route 1 at Saugatucket Road.</p>	<p>Longer-term improvements are intended to address persistent safety issues if observed in the future.</p>
